STANDARD WORK METHOD

Standard Work Instruction Sheet		SWIS ID	SOP.0738.01.SHE.Stockbay Inspection
			RA ID	Stockbays:- Inspection Procedure
	Description:	Stockbay Walls:- Visual Inspection Procedure (Various construction types)	Date	13.12.16

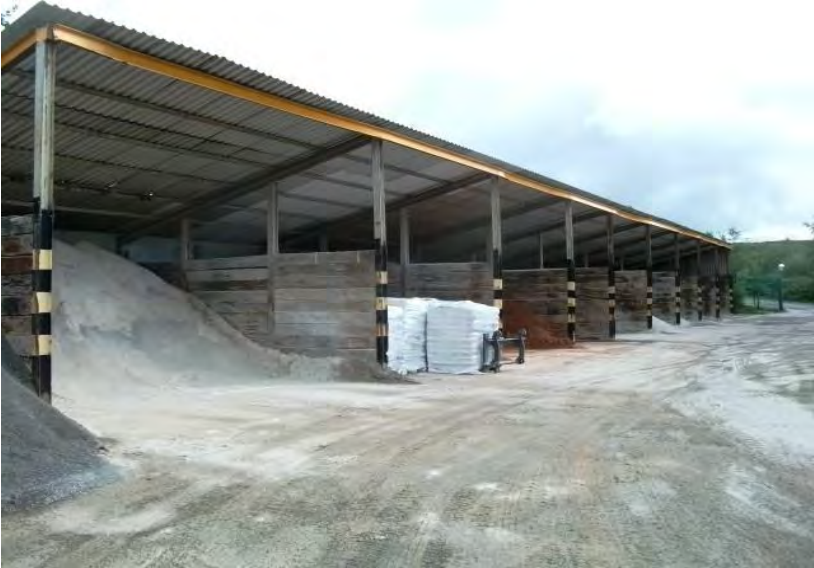
No	Full Task Description	Visual Reference
<p>2</p>	<p>Ensure the designated area is safe to carry out an inspection.</p> <p>This can be achieved by either:-</p> <ul style="list-style-type: none"> a) Carry out the inspection during non production hours or alternately b) Stop mobile plant operating around the stockbays for the duration of the inspection. 	<p>Stockbays Example</p>

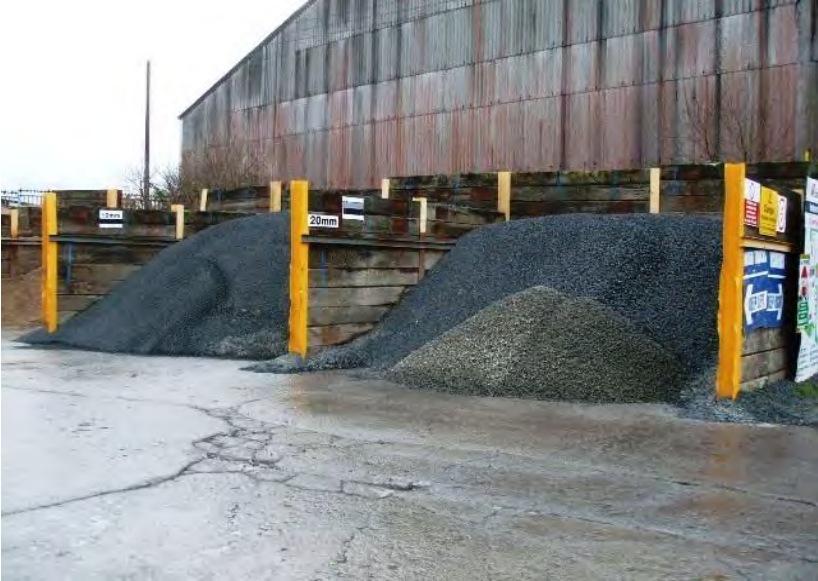
No	Full Task Description	Visual Reference
5	<p>Wall Type 1:-</p> <p>Open Stockbays Wooden or concrete sleepers stacked laterally to form a vertical wall that locates in a series of equi-spaced rolled steel posts. The top of the posts finish approximately level with the top sleeper leaving all stocked material fully open to the weather. Photo examples 001 – 004 inclusive.</p> <p>Covered Stockbays Very similar in design to the above open stockbays other than the rolled steel posts continue past the top sleeper in order to provide support to profiled steel clad walls and an overhead profiled steel clad roof. The stocked material is therefore partially protected from the weather. Photo examples 005 & 006.</p> <p>Overhead Conveyor Discharge Stockbays Some storage assemblies also have overhead tripper car conveying systems and associated maintenance walkways in order to feed material directly into the individual bays. Photo examples 007 & 008.</p> <p>Washing & Screening Plant Stockbays Additionally material can also be discharged and stored under washing and screening plant assemblies using similar wall constructions. Photo example 009.</p> <p>Inspection Procedure:- See item 6</p>	<p>Photo 001 Wooden Sleepers Example – Wall Type 1</p>

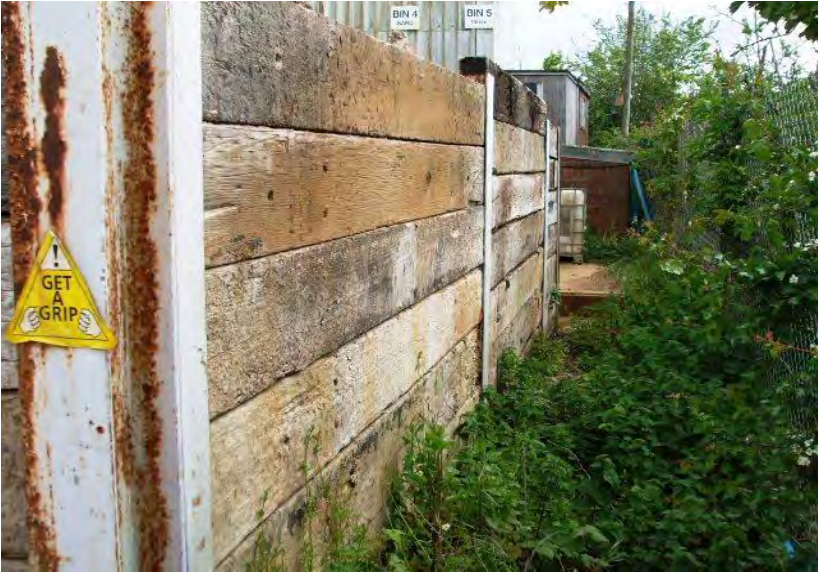
<p>Photo 002 Wooden Sleepers Example – Wall Type 1</p>

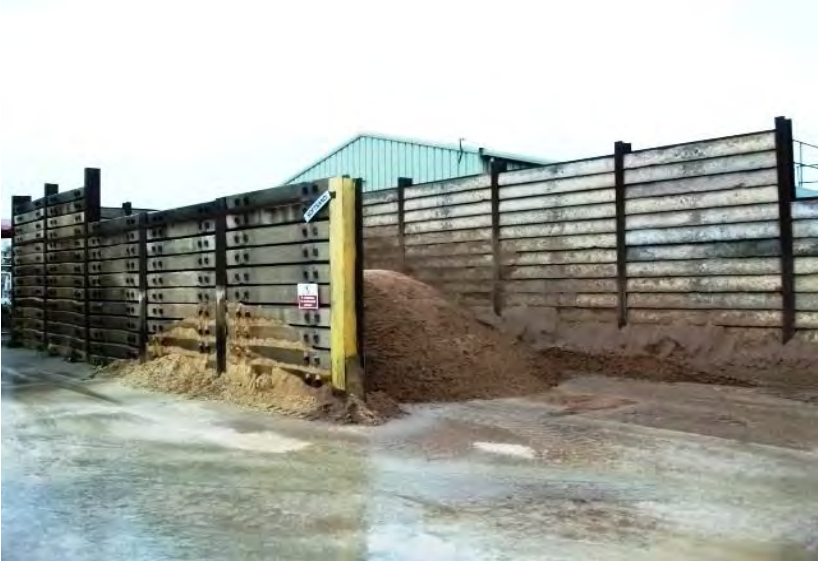
No	Full Task Description	Visual Reference
5 Cont'd		<p data-bbox="1198 167 1825 199">Photo 003 Concrete Sleepers Example – Wall Type 1</p>

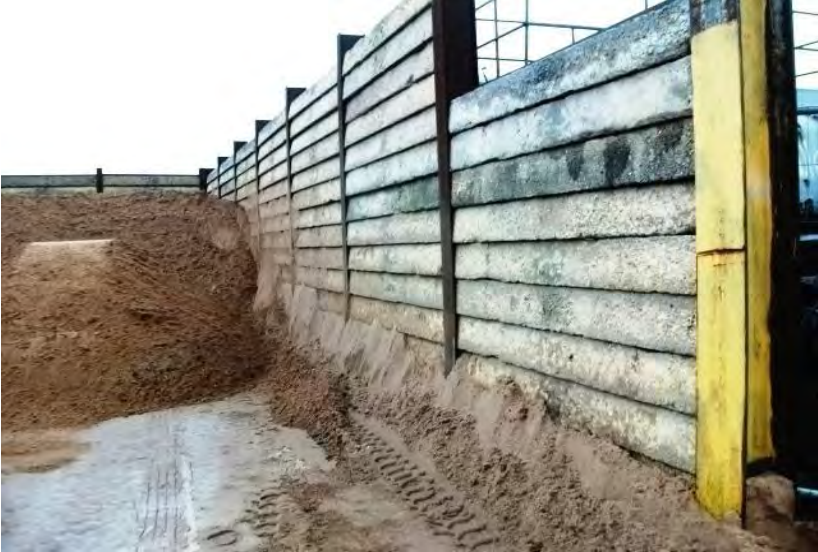
<p data-bbox="1198 805 1825 837">Photo 004 Concrete Sleepers Example – Wall Type 1</p>

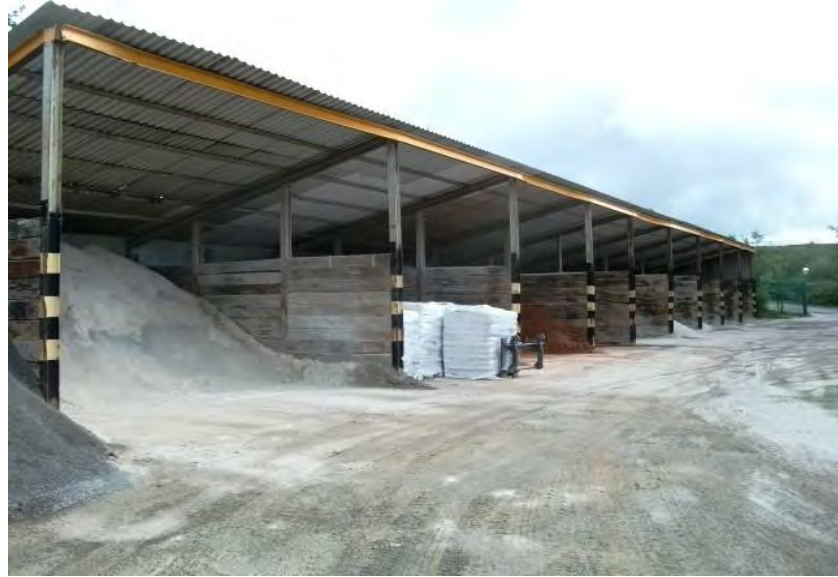
No	Full Task Description	Visual Reference
5 Cont'd		<p data-bbox="1198 167 1825 199">Photo 005 Covered Stockbay Example – Wall Type 1</p>

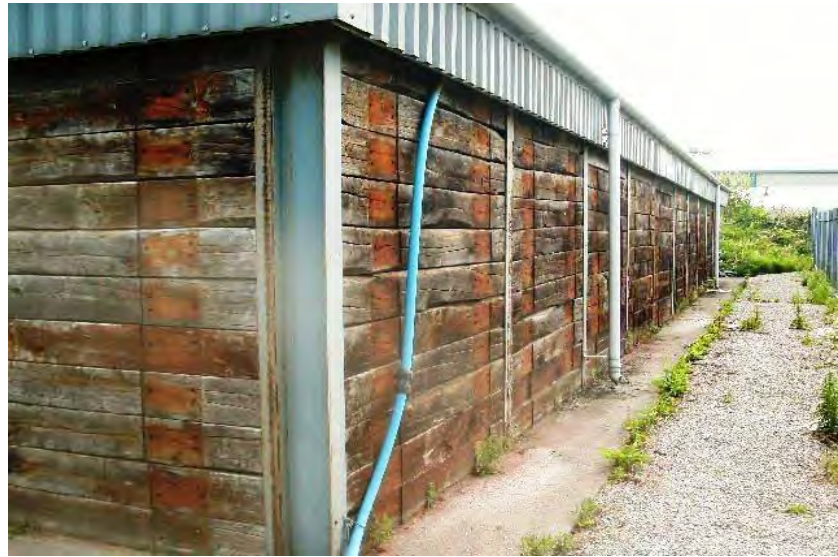
<p data-bbox="1198 813 1825 845">Photo 006 Covered Stockbay Example – Wall Type 1</p>

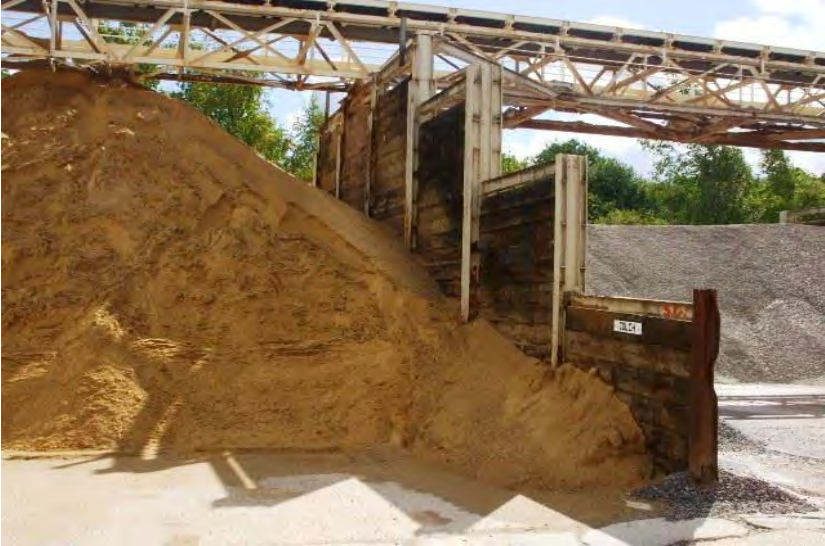
No	Full Task Description	Visual Reference
5 Cont'd		<p data-bbox="1198 167 1944 199">Photo 007 Overhead Conveying System Example – Wall Type 1</p>

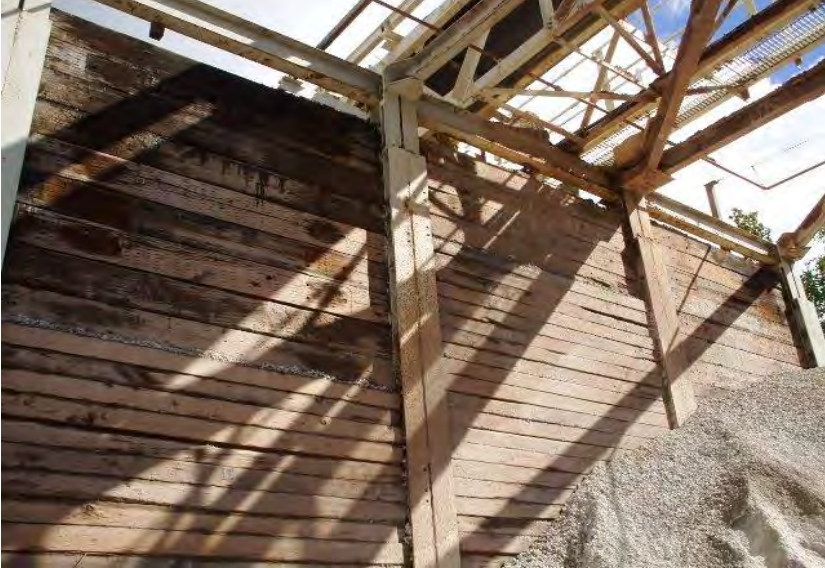
<p data-bbox="1198 790 1944 821">Photo 008 Overhead Conveying System Example – Wall Type 1</p>

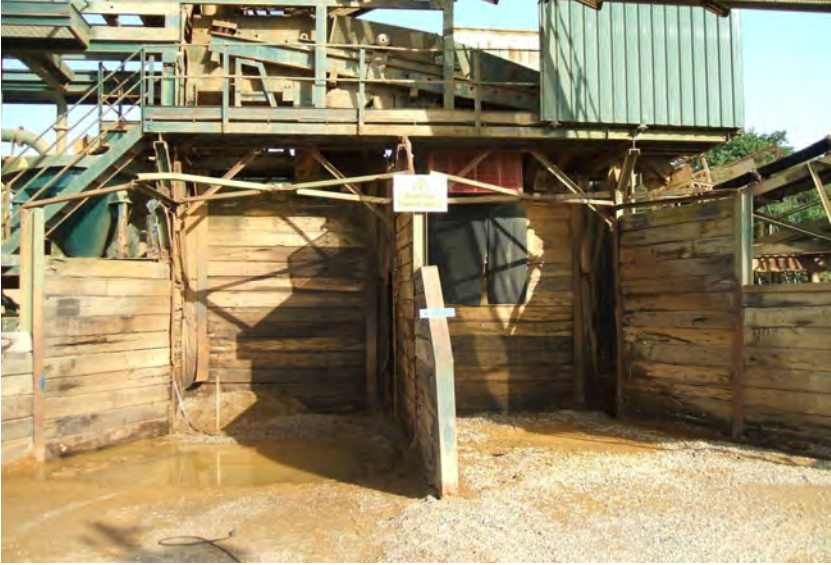
No	Full Task Description	Visual Reference
5 Cont'd		<p data-bbox="1198 167 2116 199">Photo 009 Washing & Screening Plant Discharge Bays Example – Wall Type 1</p>

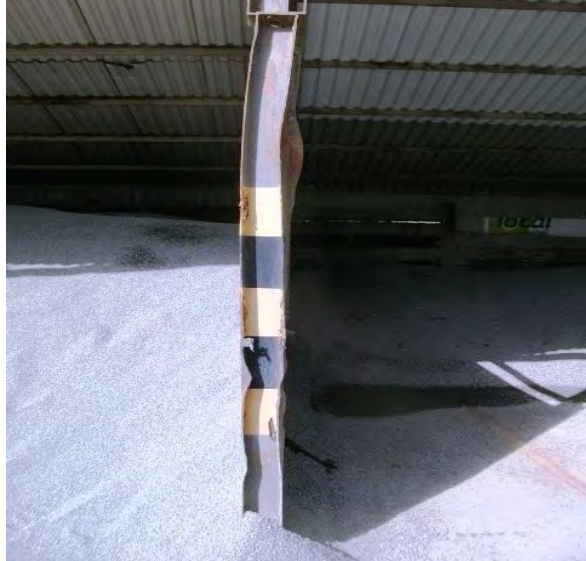
No	Full Task Description	Visual Reference
<p data-bbox="114 172 136 204">6</p> <p data-bbox="208 172 1155 268">Wall Type 1:- Wooden or concrete sleepers stacked laterally to form a vertical wall. Some stockbays are fully open to the weather whilst others are partially covered. The walls can also support overhead conveyors or plant equipment.</p> <p data-bbox="208 316 1149 411">Please note:- All defects uncovered during the inspection will require address by the individual sites. An Engineer should be contacted to further discuss any points.</p> <p data-bbox="208 491 739 523">The inspection requirements are as follows:-</p> <ul data-bbox="255 563 1137 778" style="list-style-type: none"> • Inspect all vertical structural members for any significant collision damage. Photos 010 & 011. • All structural steelwork that has suffered significant collision damage must be reported asap to ensure the integrity of the structure has not been compromised. 		<p data-bbox="1200 172 2022 204">Photo 010 Example of damaged and distorted member – Wall Type 1</p>

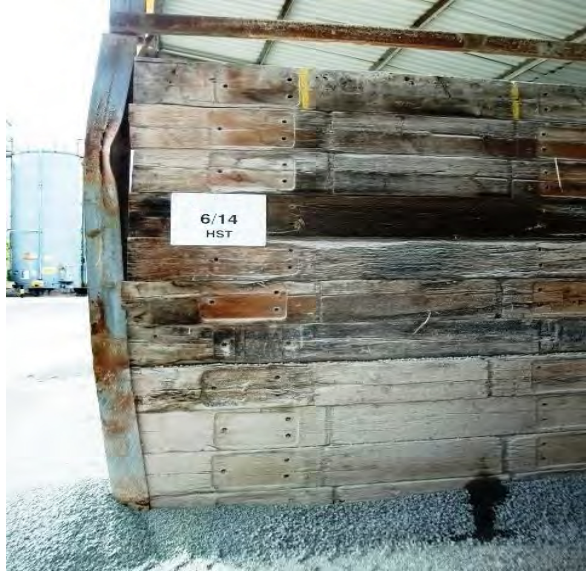
<p data-bbox="1200 802 2022 834">Photo 011 Example of damaged and distorted member – Wall Type 1</p>

No	Full Task Description	Visual Reference
<p>6 Cont'd</p>	<ul style="list-style-type: none"> Inspect the full height of all walls to see whether any collision damage to the vertical members has resulted in the sleeper ends not being fully captive. Photos 011 & 014. Inspect the vertical walls for alignment. They could have suffered collision damage or been subject to internal forces from either the loading shovels or pressure of the materials against them. Photos 015 & 016. The top of the wall should be within a lateral tolerance of 100mm from its original position. 	<p>Photo 014 Example of sleepers that are not held captive – Wall Type 1</p>

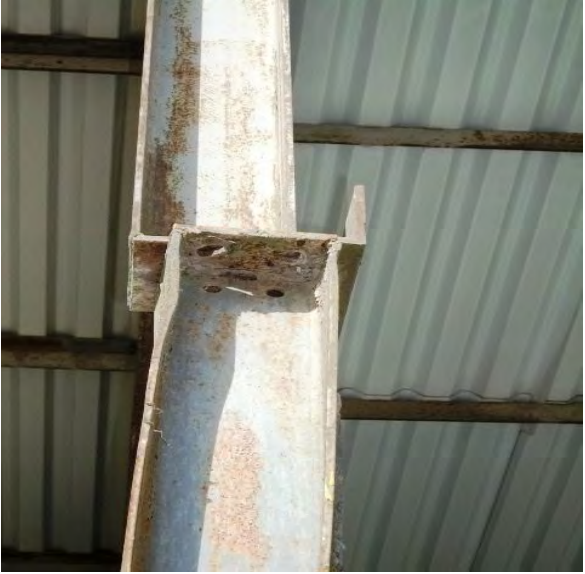
No	Full Task Description	Visual Reference
6 Cont'd	<ul style="list-style-type: none">• Check to see if any bolted sections have bolts missing and as a result have become misaligned and not secure. Photo 012.• Check to see whether baseplates have suffered significant damage and have loosened or sheared anchor bolts. Photo 013.	<p>Photo 012 Example of missing cap plate bolts – Wall Type 1</p>

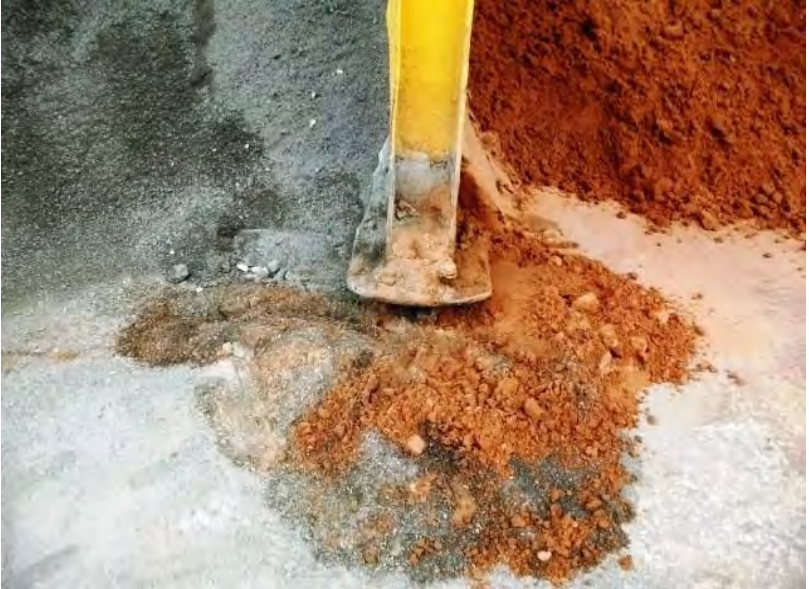
<p>Photo 013 Example of lifted baseplate / loose anchor bolts – Wall type 1</p>

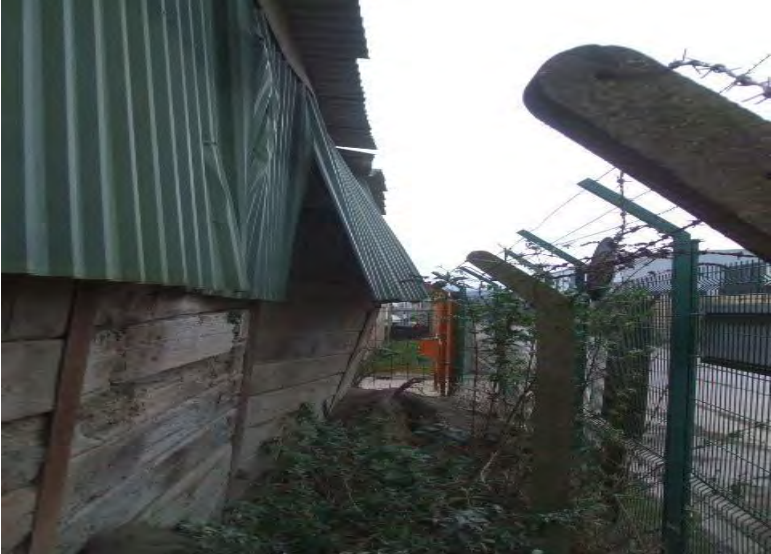
<p>Photo 015 Example of rear wall that has canted over – Wall Type 1</p>

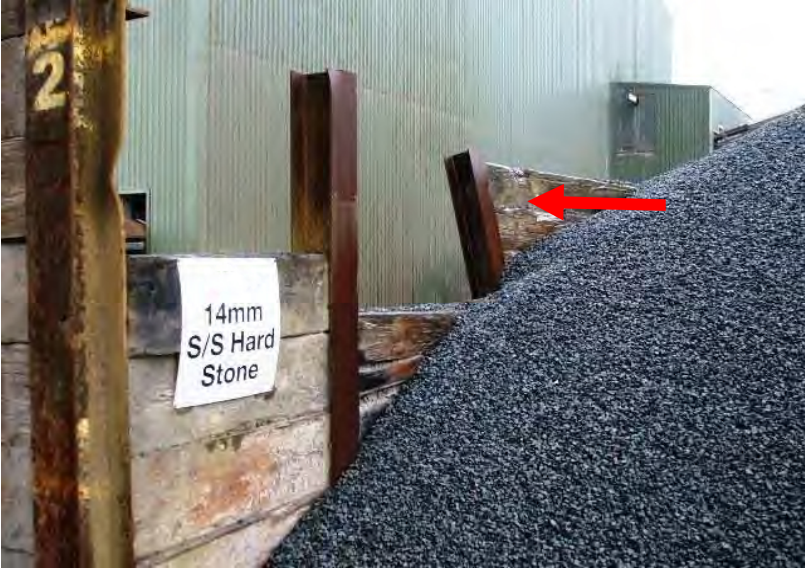
No	Full Task Description	Visual Reference
<p data-bbox="69 172 181 252">6 Cont'd</p> <ul data-bbox="255 204 1115 271" style="list-style-type: none"> <li data-bbox="255 204 1115 271">• Inspect the vertical members for significant corrosion deterioration. Photo 017. 		<p data-bbox="1198 167 1836 199">Photo 016 Example of canted over post – Wall Type 1</p>

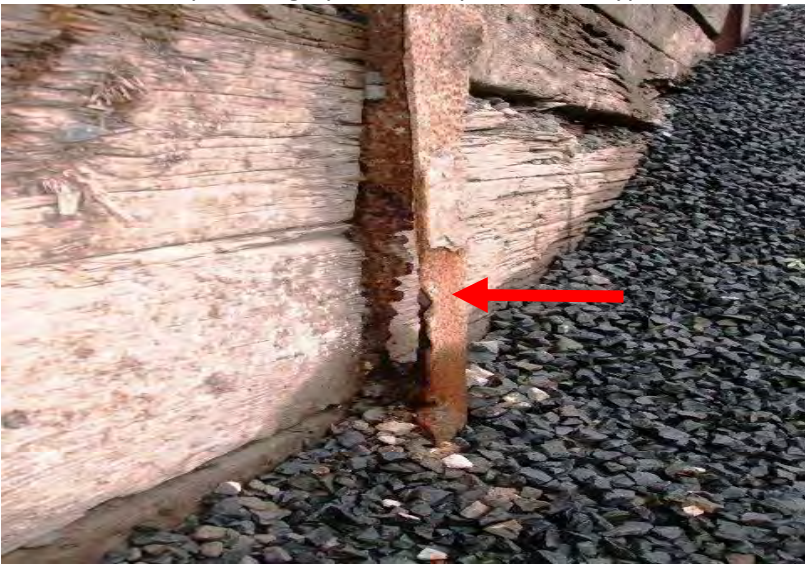
<p data-bbox="1198 805 1881 837">Photo 017 Example of highly corroded post – Wall Type 1</p>

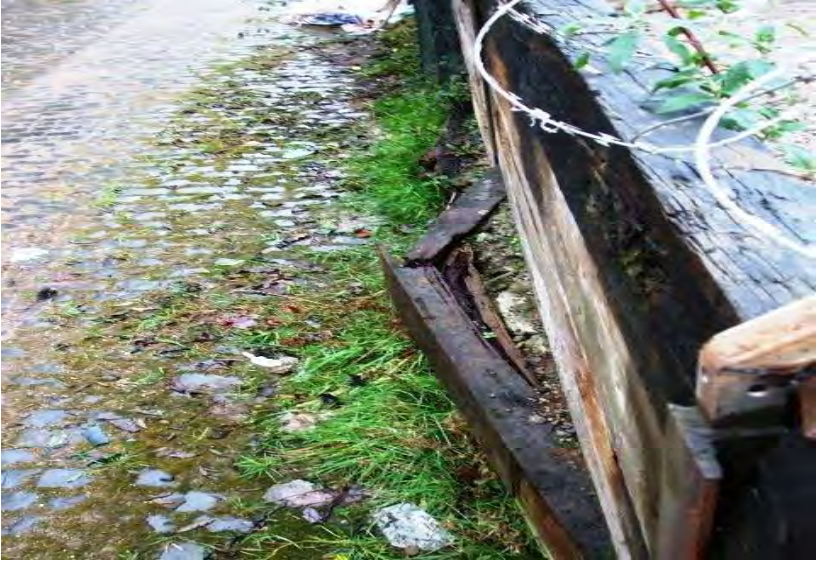
No	Full Task Description	Visual Reference
<p>6 Cont'd</p>	<ul style="list-style-type: none"> Inspect the individual sleepers for rot in order to prevent failure. Photo 018. Where the structure is clad, all panels require inspection for damage and failed fixings. Any loose sections that could become dislodged in high winds require address. Photo 019. 	<p>Photo 018 Example of rotting & broken sleeper – Wall Type 1</p>

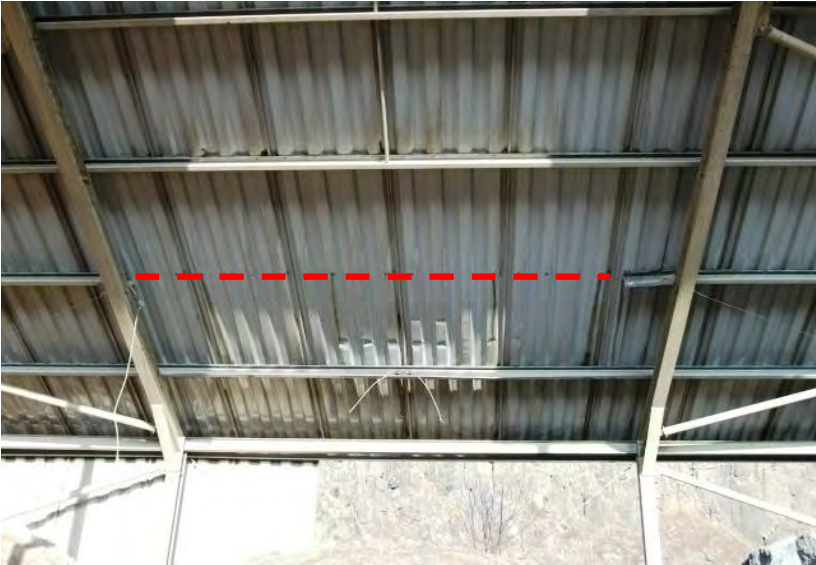
<p>Photo 019 Example of missing purlin / loose cladding panels – Wall Type 1</p>

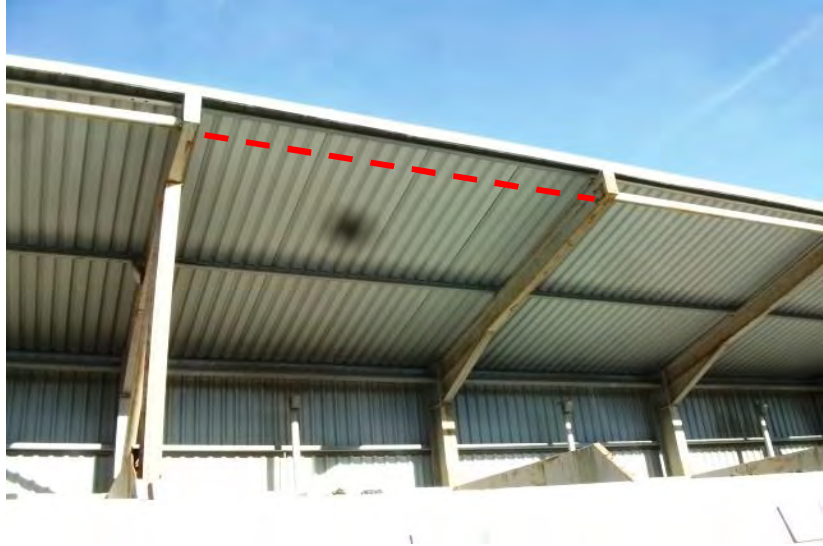
No	Full Task Description	Visual Reference
<p>6 Cont'd</p>	<ul style="list-style-type: none"> Inspect all ties and bracings for damage or distortion on all the sides and also on the underside of the roof of covered storage bays. Photos 020. 	<p>Photo 020 Example of missing canopy frame member – Wall Type 1</p>

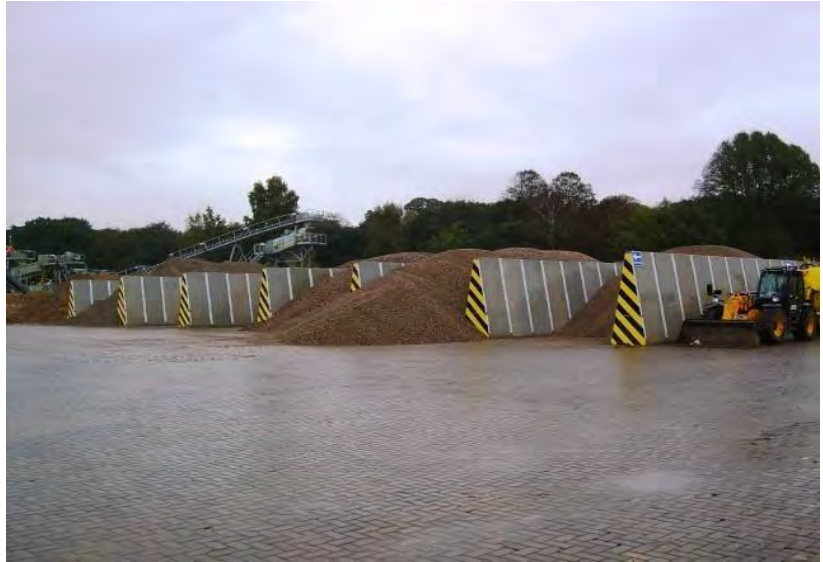
<p>7</p>	<p>Wall Type 2:-</p> <p>Precast and prestressed concrete A frame units (also called Alfablocs) are positioned in a straight line and are either freestanding or can be anchored to a concrete foundation (for higher loading applications) and are mechanically fixed to each other. They range in height from 1.22m – 6m. Photo example 021.</p> <p>Inspection Procedure:- See item 8</p>	<p>Photo 021 A Frame Example – Wall Type 2</p>

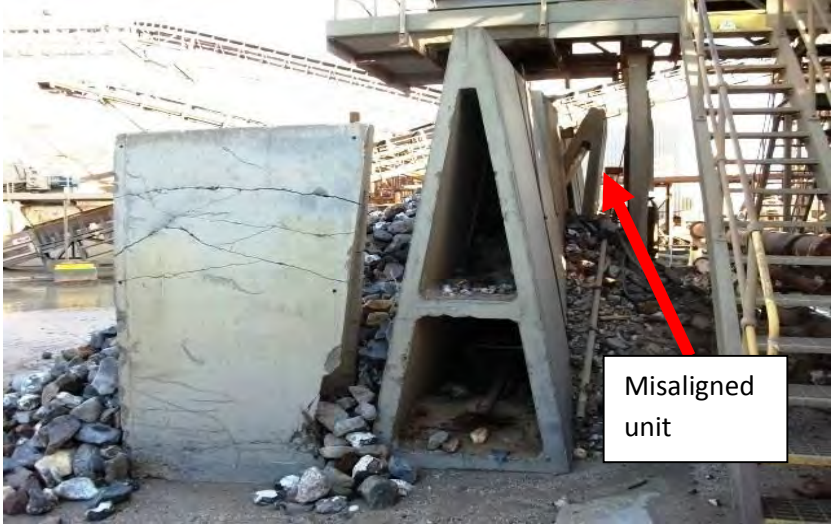
No	Full Task Description	Visual Reference
8	<p>Wall Type 2:- Precast concrete A frame units are positioned in a straight line and are anchored to each other. Some walls will be freestanding whilst others will be anchor bolted to a concrete slab foundation. In instances where they are not bolted down they may sit on compacted ground and not necessarily on concrete.</p> <p>The inspection requirements are as follows:-</p> <ul style="list-style-type: none"> Assess that the retaining wall is relatively plumb. The apex of the wall should be within a lateral tolerance of 100mm from its original position. Photo 022. If ground anchor bolts are fitted, check that all base fixings remain intact and have not partially or fully pulled out. Check the mechanical fixings that run vertically between all the individual units remain intact. (i.e, check that the joints have not pulled apart in some manner). Photo example 023. 	<p>Photo 022 Example of Misaligned Unit – Wall Type 3</p>

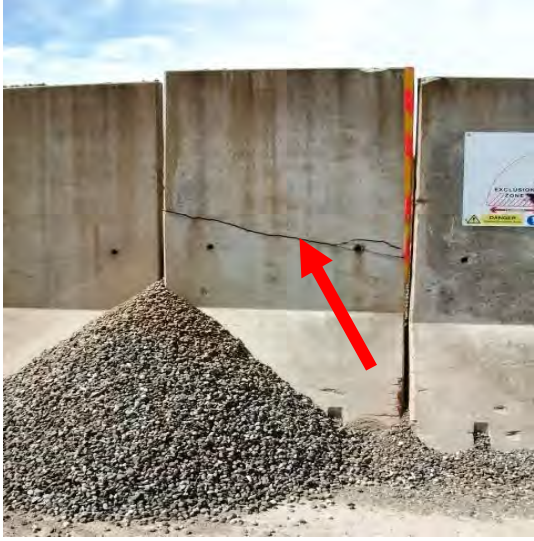
No	Full Task Description	Visual Reference
<p>8 Cont'd</p>	<ul style="list-style-type: none"> • Check that the panels have not completely fractured to the point where only the rebars hold them together. Localised damage is to be expected over time, which manifests in partial fracture, spalling and occasionally punched holes. A judgement therefore has to be made regarding the severity of the damage. Photo examples 024 & 025. • As mentioned, some A frame walls are not anchor bolted to a concrete foundation and only sit on compacted ground. There is therefore an increased possibility of movement in these instances. An excessive force from a loading shovel bucket can potentially lift up a section of wall or move it laterally. If a section of wall is accidentally raised up it tends to drop back down into position relatively quickly as each precast section is tied vertically along its joints to its neighbouring units. There is therefore considerable weight acting against any uplift. However, stored material can also swiftly flow underneath. Lateral movement can also occur where overfilling or excessive vehicle force gradually pushes a wall into a bowed position. It has been known for a wall to slide up to 1m from its original position. Each wall therefore requires checking to ensure that it is reasonably straight in line and level. If aggregate has got under any areas resulting in any noticeably raised sections, then the material requires removal and if a wall has moved laterally in excess of 0.5m then it requires realignment. It may be necessary to review the filling and emptying operations if this problem repeats itself or to investigate fitting foundation anchor bolts if the walls sit on a concrete foundation. 	<p>Photo 024 Example of an Acceptable Concrete Fracture (taperbloc wall)</p>

No	Full Task Description	Visual Reference
12	<p>Wall Type 4:- Precast concrete Taperbloc units are positioned in a straight line and are fully independent of each other. The lighter units with the hollow triangular bases are designed to be anchor bolted to a concrete foundation whilst the heavier solid triangular bases are designed to be freestanding. In instances where they are not bolted down they may sit on compacted ground and not necessarily on concrete.</p> <p>The inspection requirements are as follows:-</p> <ul style="list-style-type: none"> Assess that the retaining wall is relatively plumb. The apex of the wall should be within a lateral tolerance of 100mm from its original position. If ground anchor bolts are fitted, check that all base fixings remain intact and have not partially or fully pulled out. If aggregate has got under any areas resulting in any noticeable raised sections of wall, then the material should be removed to enable the panels to be realigned and fully bolted down. Photo 032. Check that the panels have not completely fractured to the point where only the rebars hold them together. Localised damage is to be expected over time, which manifests in partial fracture, spalling and occasionally punched holes. A judgement has to be made regarding the severity of the damage. See photo examples 024 & 025. 	<p>Photo 032 – Example of Raised Unit – Wall Type 5</p>

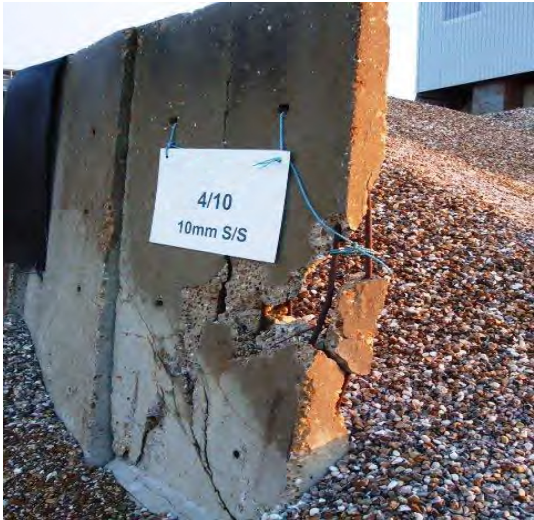
<p>Photo 025 Example of an Unacceptable Concrete Fracture & Localised Damage (L frame wall)</p>

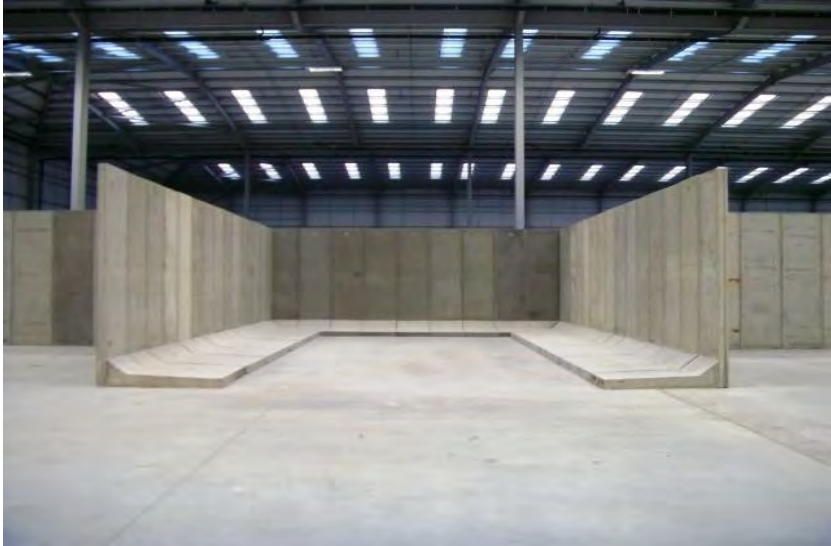
No	Full Task Description	Visual Reference
<p data-bbox="107 167 138 204">9</p> <p data-bbox="206 167 414 204">Wall Type 3:-</p> <p data-bbox="206 247 1164 459">Precast concrete L frame units (also called L blocs) are positioned in a straight line and are always anchored to a concrete foundation. Some manufacturers tie each unit together via a tongue and groove joint arrangement whilst others leave them fully independent. Some manufacturers also offer prestressed units whilst others don't. They range in height from 3.6m (standard) – 5m. Photo examples 026 & 027.</p> <p data-bbox="206 502 750 539">Inspection Procedure:- See item 10</p>		<p data-bbox="1198 167 1702 204">Photo 026 L Frame Example – Wall Type 3</p>

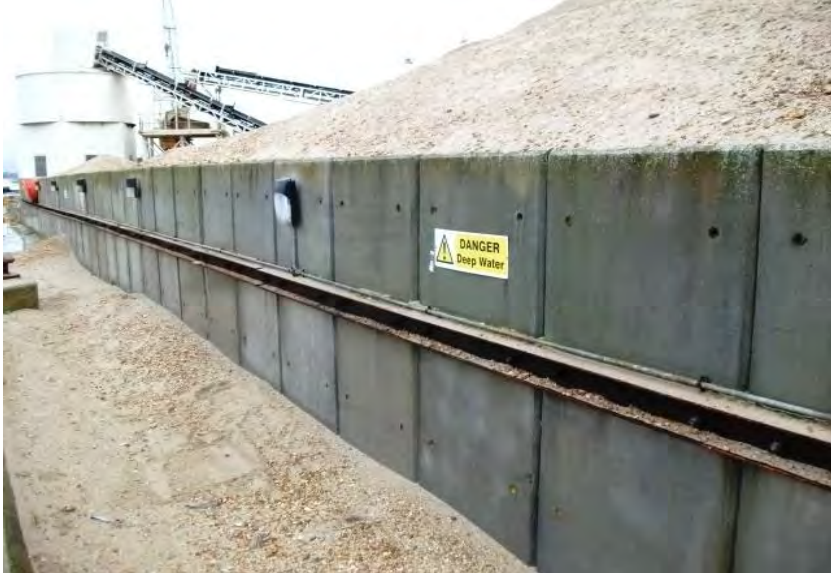
<p data-bbox="1198 790 1702 826">Photo 027 L Frame Example – Wall Type 3</p>

No	Full Task Description	Visual Reference
<p>12 Cont'd</p>	<ul style="list-style-type: none"> As mentioned, some solid Taperbloc walls are not anchor bolted and some walls only sit on compacted ground. There is therefore an increased possibility of movement in these instances. An excessive force from a loading shovel bucket can potentially lift up a section of wall or move it laterally. Lateral movement can also occur where overfilling or excessive vehicle force gradually pushes a wall into a bowed position. It has been known for a wall to slide up to 1m from its original position. Each wall therefore requires checking to ensure that it is reasonably straight in line and level. If aggregate has got under any areas resulting in any noticeably raised sections of wall, then the material requires removal and if a wall has moved laterally in excess of 0.5m leaving significant gaps between adjacent units for material to flow through then it requires realignment. It may be necessary to review the filling and emptying operations if this problem repeats itself or to investigate fitting foundation anchor bolts if the walls sit on a concrete foundation. Consideration can also be given to bolting a continuous channel member across the units to assist with their rigidity. See photo example 027.

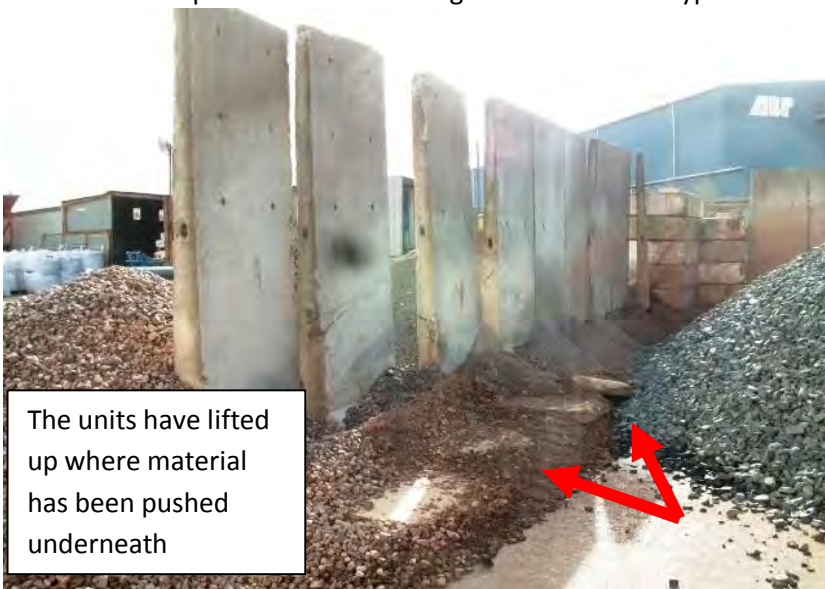
No	Full Task Description	Visual Reference
10	<p>Wall Type 3:- Precast concrete L frame units are positioned in a straight line. Some will be anchored to each other by various tongue and groove vertical joint methods whilst some are fully independent. They are all bolted to the concrete slab foundation and are not freestanding.</p> <p>The inspection requirements are as follows:-</p> <ul style="list-style-type: none"> • Assess that the vertical retaining wall is relatively plumb. The top of the wall should be within a lateral tolerance of 100mm from the vertical position. Photo 028. • Check that base fixings remain intact and have not partially or fully pulled out. The panels can become unstable if they are not fully anchored. Photo 029. If aggregate has got under any areas resulting in any noticeable raised sections of wall, then the material should be removed to enable the panels to be realigned and fully bolted down. • Check that the joints that run vertically between all the individual units remain intact particularly the types where they incorporate a tongue and groove joint of some description. (i.e, check that the joints have not pulled apart). Photo 030. If experience has indicated that the panels tend to move over time then a continuous channel member can be bolted across the back of the units to improve their rigidity. See photo example 027. • Check that the panels have not completely fractured to the point where only the rebars hold them together. Localised damage is to be expected over time, which manifests in partial fracture, spalling and occasionally punched holes. A judgement has to be made regarding the severity of the damage. See photo examples 024 & 025. 	<p>Photo 028 Example of Misaligned Units – Wall Type 3</p>   <p>Photo 029 Example of Raised & Misaligned Units – Wall Type 3</p>

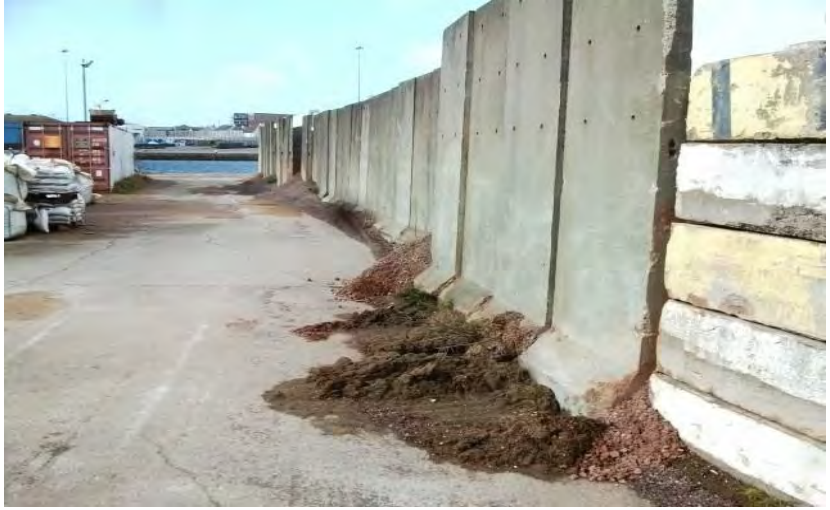
No	Full Task Description	Visual Reference
<p>10 Cont'd</p>		<p>Photo 030 Example of Raised & Misaligned Units – Wall Type 3</p>

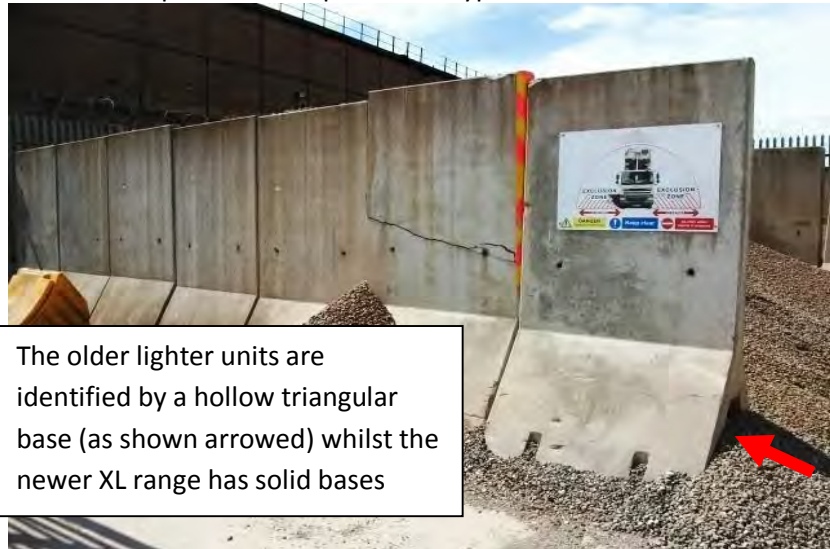
<p>11</p>	<p>Wall Type 4:-</p> <p>Precast concrete taperbloc units are positioned in a straight line, the older generation are lighter and therefore require anchor bolting to a concrete foundation whilst the newer taperbloc XL range is a heavier construction and is designed to be freestanding. They range in height from 2.4m – 3.0m. Photo example 031.</p> <p>Inspection Procedure:- See item 12</p>	<p>Photo 031 Taperbloc Example – Wall Type 4</p>

<div data-bbox="1200 1173 1659 1364" style="border: 1px solid black; padding: 5px;"> <p>The older lighter units are identified by a hollow triangular base (as shown arrowed) whilst the newer XL range has solid bases</p> </div>

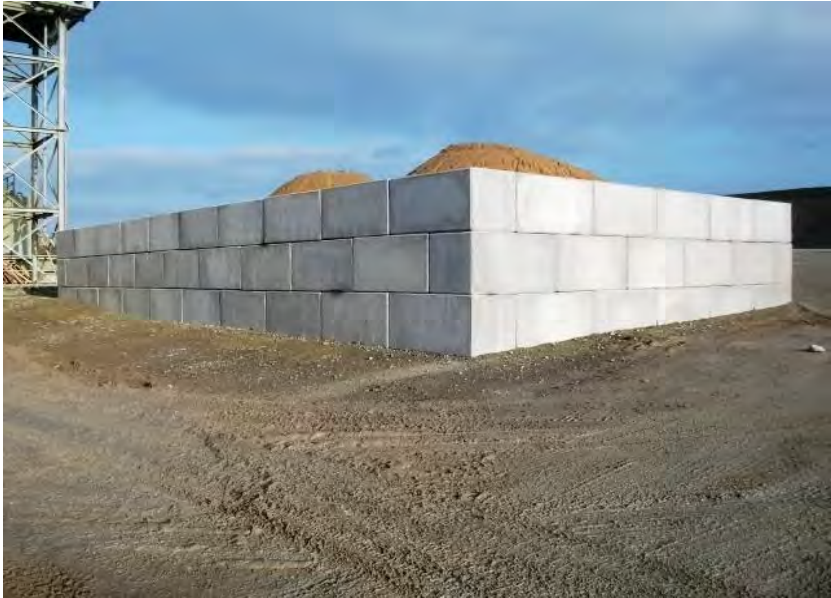
<p>13</p>	<p>Wall Type 5:-</p> <p>Precast mass concrete rectangular blocks that interlock via raised male connectors and are built in a straight line in a standard staggered joint brick formation. These are commonly called Lego blocks (also called Legato, Duo, Betablocs) and maintain their stability and rigidity without the need for any additional mechanical fixings.</p> <p>The blocks are available in various sizes, the larger blocks measure 800mm width x 800mm depth x 1600mm length whilst the smaller blocks measure in the region of 600mm width x 450mm depth x 1500mm length although the dimensions are subject to slight variation depending on the individual suppliers. The walls generally range in height up to approx 2.4m although utilising spreader footblocks can increase the height beyond this up to approx 3.2m. Photo example 033 (shows larger size blocks).</p> <p>Additional strength can also be achieved by having a double width wall (i.e, laying blocks side by side).</p> <p>Inspection Procedure:- See item 14</p>	<p>Photo 033 Lego Block Example – Wall Type 5</p>

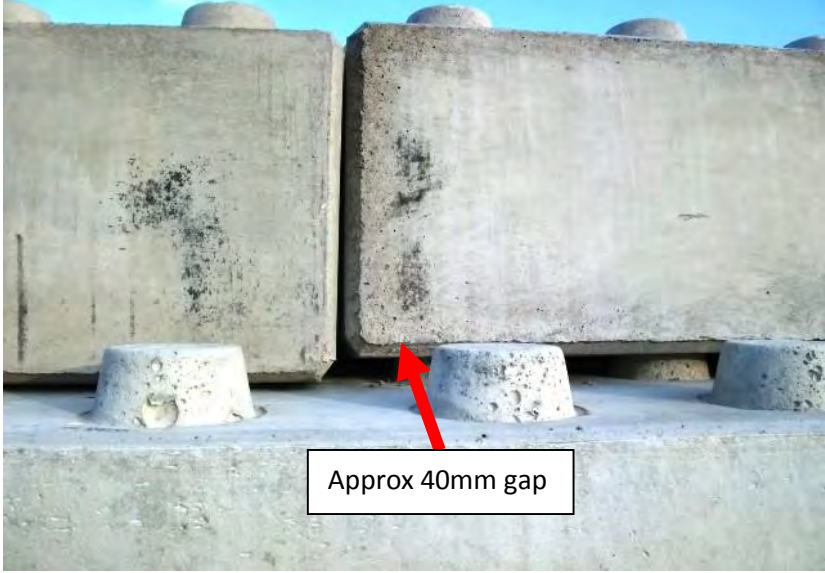
No	Full Task Description	Visual Reference
<p>14</p>	<p>Wall Type 5:- Precast concrete blocks that interlock and are built in a straight line in a brick formation. These are commonly called Lego blocks and maintain their stability and rigidity without the need for any additional mechanical fixings).</p> <p>The inspection requirements are as follows:-</p> <ul style="list-style-type: none"> • Assess that the vertical retaining wall is relatively plumb. The top of the wall should be within a lateral tolerance of 100mm from the vertical position. • Check that the block joints have not noticeably pulled apart. The joint gaps should be within the region of 0 – 10mm max. • Check that the perimeter blocks have not been accidentally pushed out of position. The top edge blocks in particular should be checked to ensure they remain in line with the wall. Any that have noticeably moved should be repositioned. Photo 034. • If irregularities can be seen, assess whether there has been any noticeable ground movement (compaction, unevenness etc). 	<p>Photo 034 – Example of a Lifting Upper Block – Wall Type 5</p>

<p>The photograph shows two concrete blocks stacked vertically. A red arrow points to a gap between the blocks, which is labeled 'Approx 40mm gap'. The blocks are light grey and have a textured surface. The gap is located at the bottom of the upper block, between the two blocks.</p>

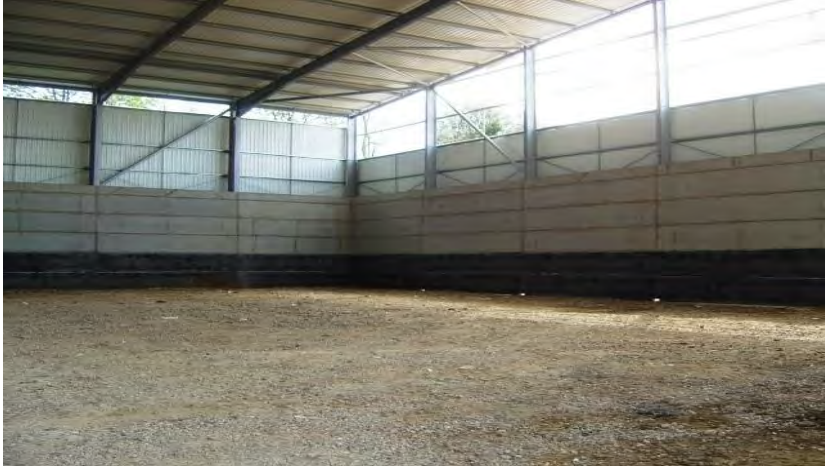
No	Full Task Description	Visual Reference
<p>15</p>	<p>Wall Type 6:-</p> <p>Precast and prestressed modular interlock panels that are mechanically fixed to the inside faces of building columns to form perimeter walls. The panels are self supporting and sit on the concrete ground slab. The lateral joints are usually tied together by a tongue and groove arrangement. Photo example 035.</p> <p>Inspection Procedure:- See item 16</p>	<p>Photo 035 Precast Modular Wall Panel Example – Wall Type 6</p>

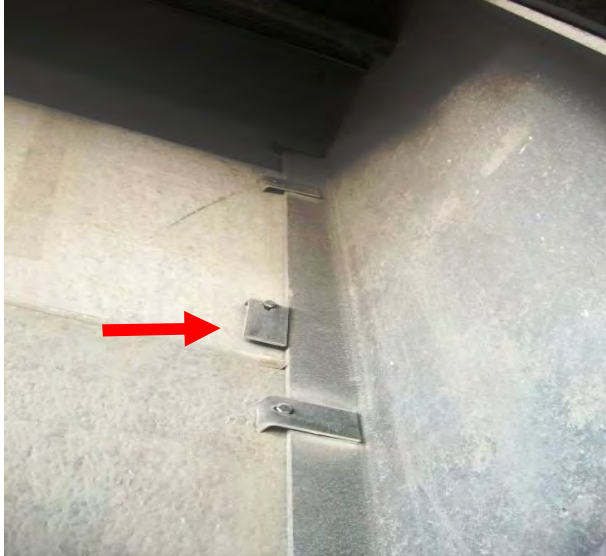
<p>16</p>	<p>Wall Type 6:- Precast and prestressed modular interlock panels that are mechanically fixed to the inside faces of building columns to form perimeter walls.</p> <p>The inspection requirements are as follows:-</p> <ul style="list-style-type: none"> • Access the rear of the panels to check that the bolts and fishplates connecting the panels to the building columns remain fully secure and tightened up. Photo 036. • Check that the panels have not completely fractured to the point where only the rebars hold them together. Localised damage is to be expected over time, which manifests in partial fracture, spalling and occasionally punched holes. A judgement has to be made regarding the severity of the damage. 	<p>Photo 036 Example of Loose Fixing Clip – Wall Type 6</p>

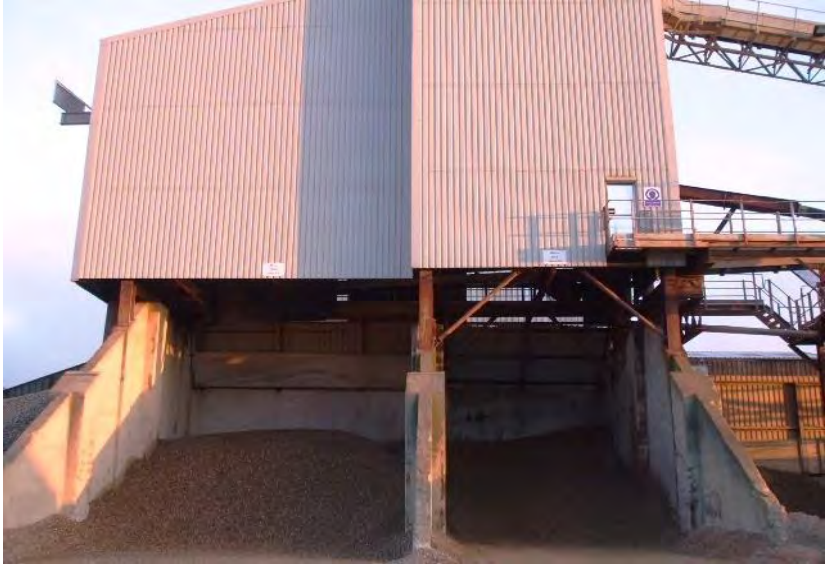
No	Full Task Description	Visual Reference
<p data-bbox="107 172 145 199">17</p> <p data-bbox="208 172 403 199">Wall Type7:-</p> <p data-bbox="208 252 1164 459">Cast in-situ concrete walls and precast concrete wall panels that are of a fixed base design and are tied into the civil foundation design of a building are not normally subject to potential instability. Photo examples 037 & 038. Walls of this type can be inspected as part of the main statutory structural survey work carried out at intervals of between 3 – 5 years. Monthly inspections are therefore considered unnecessary.</p> <p data-bbox="208 512 560 539">Inspection Procedure:-</p> <p data-bbox="208 592 1052 651">Only requires carrying out by a Structural Engineer during the statutory structural surveys.</p>		<p data-bbox="1205 172 1736 199">Photo 037 Cast in-situ Example – Wall Type 7</p>

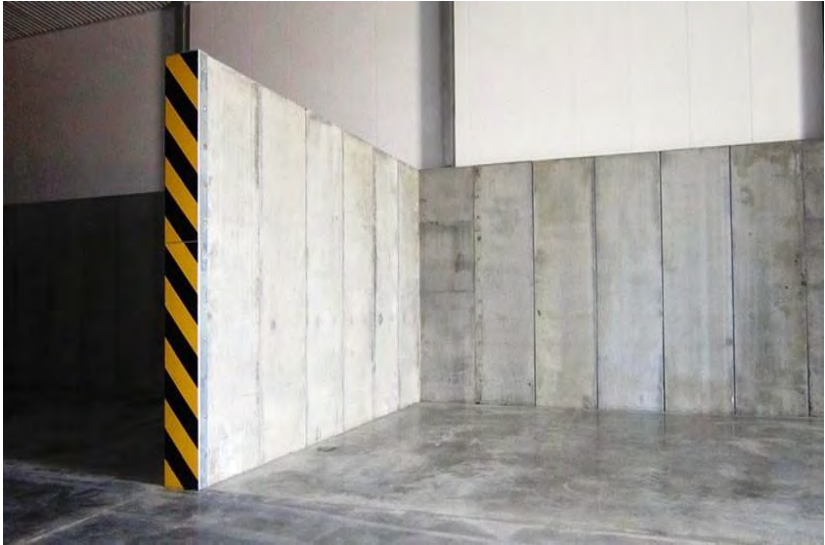
<p data-bbox="1205 805 1915 833">Photo 038 Cast in-situ Retaining Wall Example – Wall Type 7</p>
